**Subject:** TECH TALK NO. 42

## **SITING OF VAPOUR OUTLETS ON TANKER WALKWAYS**

# LOCATION OF PRESSURE/VACUUM VENT BY AIR ACTUATORS

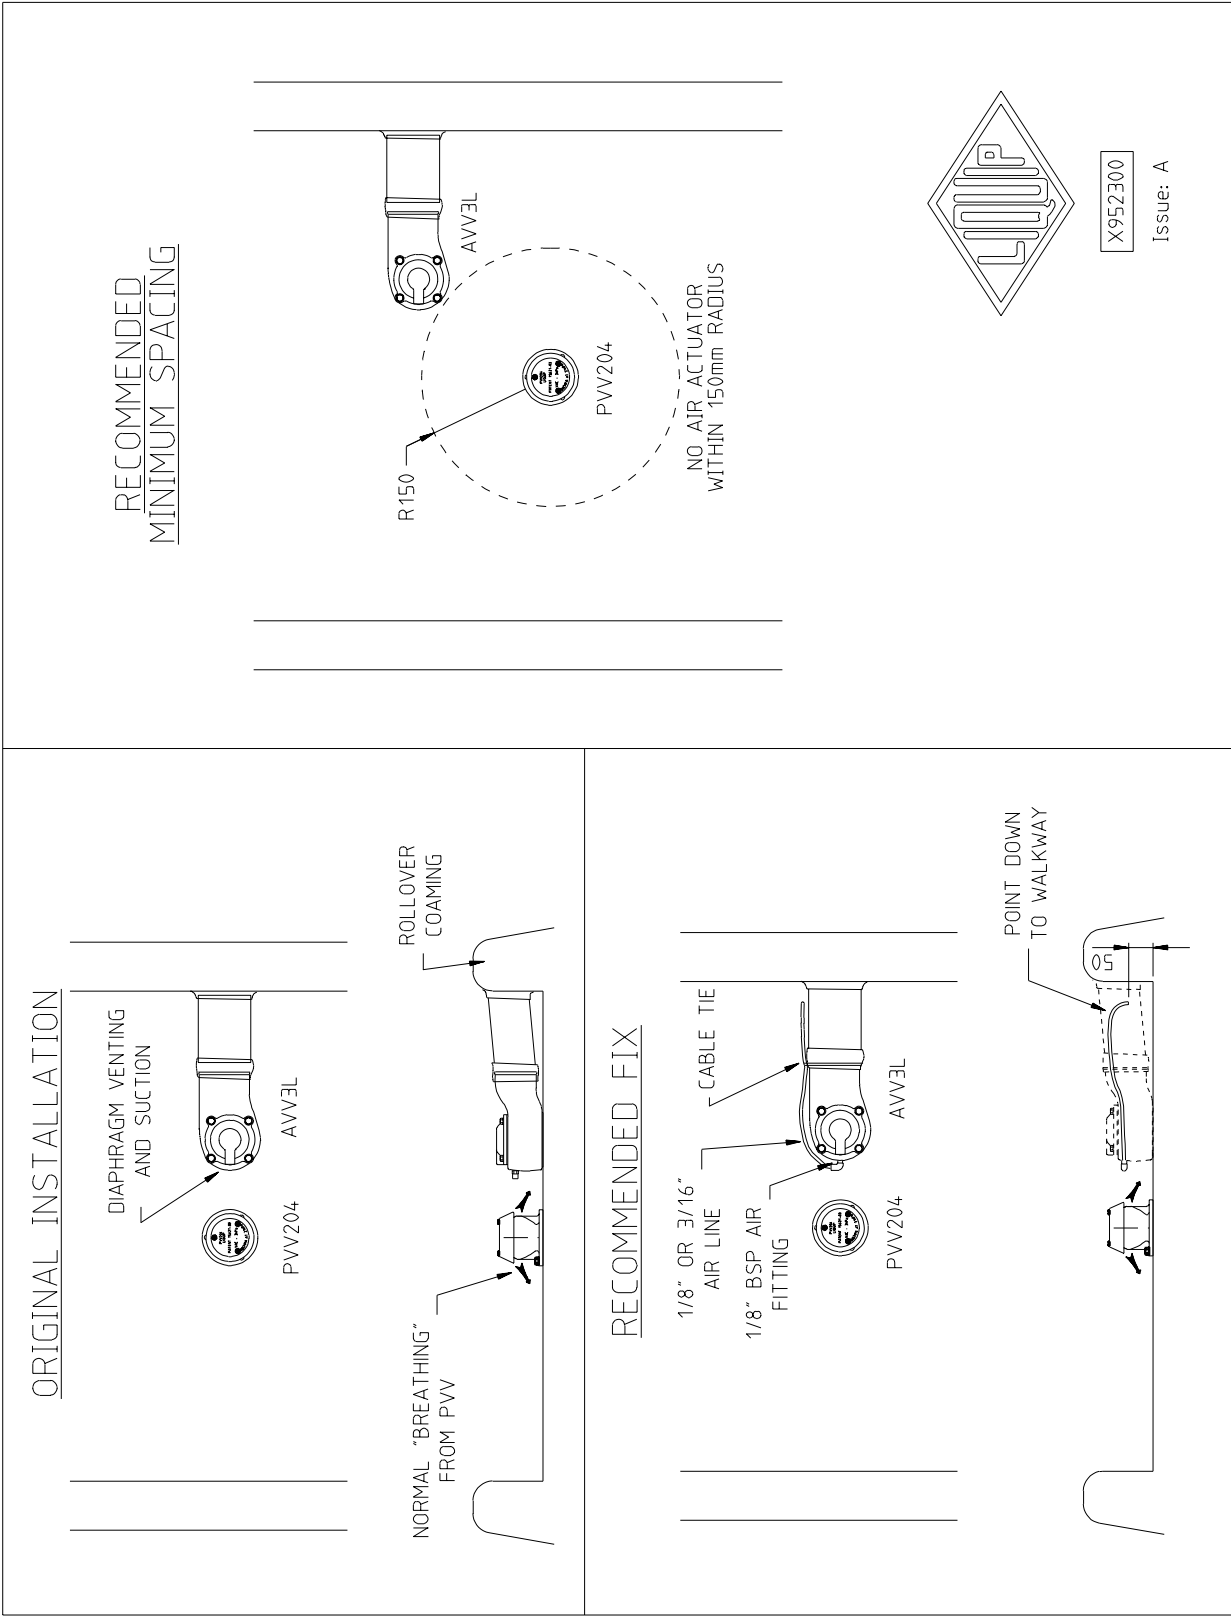
A site visit revealed the culprit. The pressure-vacuum vent, PVV204, was situated directly behind the vapour vent AVV3L in such a way that the exhaust port of the AVV3L was ingesting vapour directly out of the PVV204. There was also evidence from the Operators that the vapour return system at the loading site was causing excessive pressure, opening the pressure poppet and so exaggerating the problem. (The other tankers, which operated without problems, have a different equipment layout).

In order to play safe, it is recommended any vapour outlet, be it a pressure-vacuum vent or a non-ducted vapour vent outlet, be sited at least 150mm away from actuators or other equipment which can breathe in harmful quantities of vapour.
